NASA CONTRACTOR REPORT 166341

Testing of the Kuiper Airborne Observatory
91-CM Telescope

Robert E. Parks
Optical Sciences Center

CONTRACT NAS2-10085
July 1979

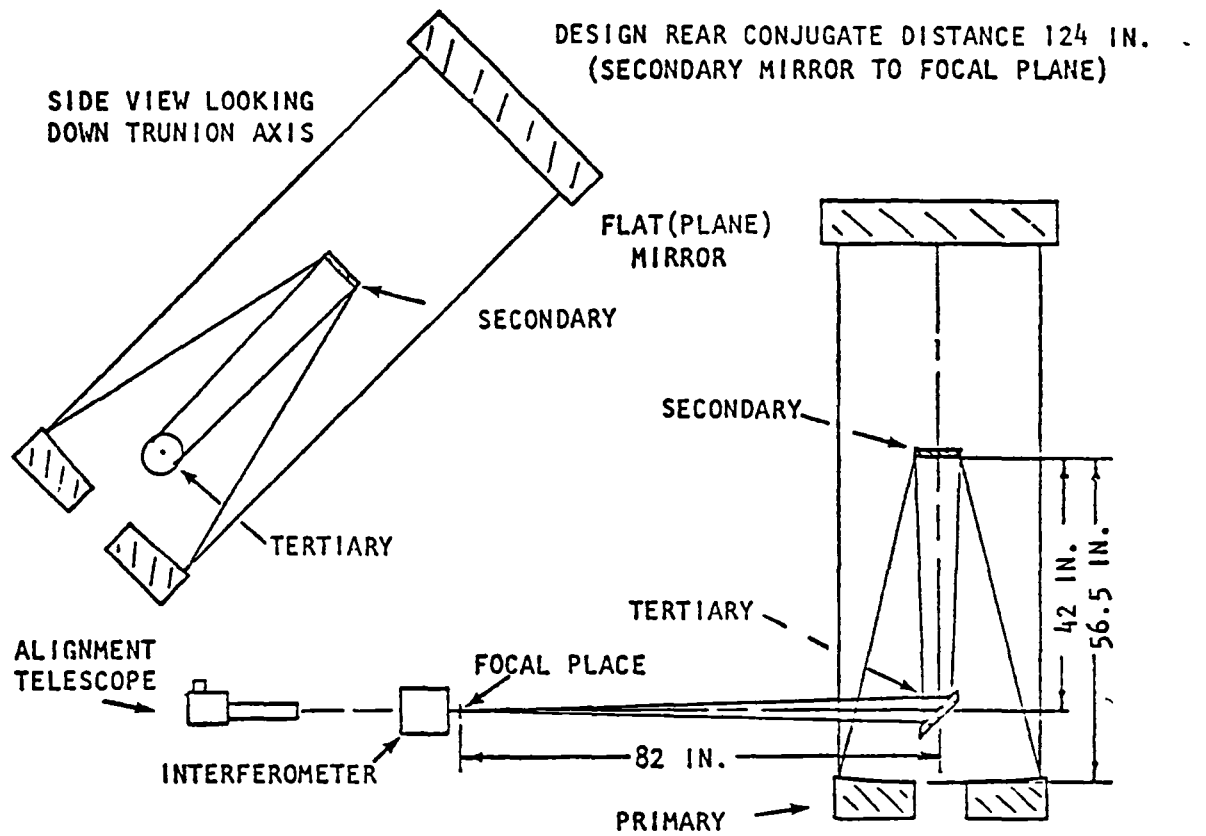
Fig. 1. System Test Against a Plane Mirror.

The method of performing the system test is illustrated in Fig. 1. The telescope was set up at 45° from zenith looking at a 40-in. diameter optical flat. An interferometer was placed in the focal plane of the telescope looking in the trunion axis at the tertiary mirror. The optical path is as shown in the figure with the light from the interferometer going from the image plane to the tertiary, the secondary, the primary, and finally hitting the flat at normal incidence. From the flat the light returns by the same path back to the interferometer making a complete double pass through the telescope. When this test was originally set up, we found that the fringe pattern had so many fringes that it was impossible to perform an interferometric test. We then replaced the interferometer with an alignment telescope and discovered that the secondary mirror was lying 3 mm off axis. This amount of decenter would have yielded 48 fringes of coma in the test setup we had. Thus the

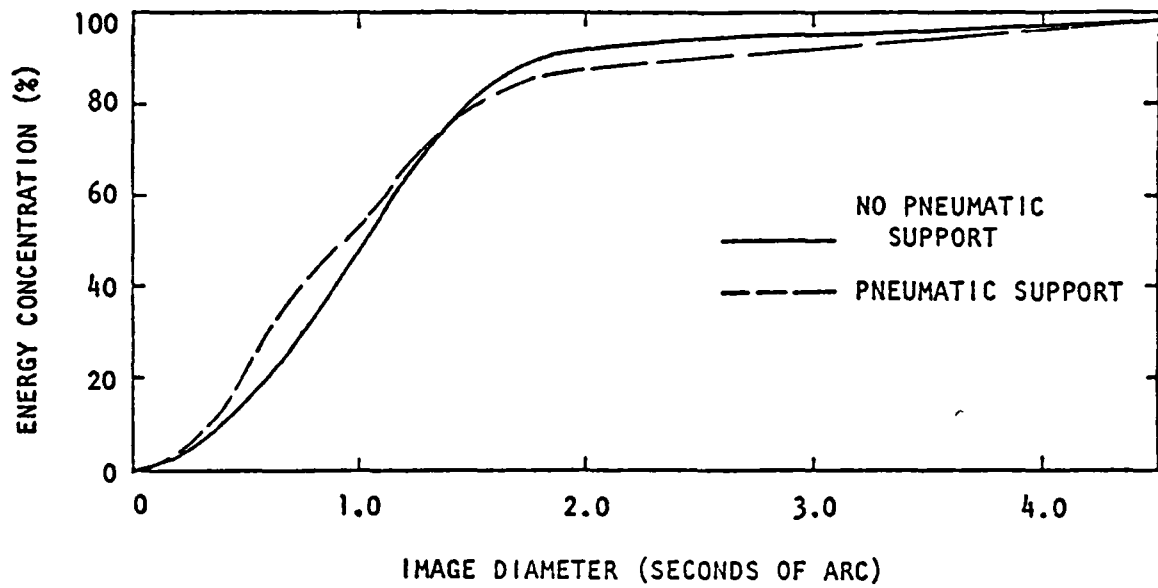
Fig. 2. Energy Concentration vs Image Diameter from Static System Interferometric Test.

The results of the interferometric tests, which are a measure of the wavefront quality through the telescope, were reduced on a computer program called FRINGE to yield the actual encircled energy produced by the wavefront going through the telescope. These numbers were divided by 2 to account for the fact that during the test the light traverses the telescope twice. The resulting energy concentration for the telescope is shown in Fig. 2. The two curves in the figure represent energy concentration both with the air support for the primary turned on and for the case where the air is turned off and the primary is resting solidly on the three defining points. As can be seen from the curve, although there is slight variation in energy concentration as a function of spot diameter, the ultimate performance of the telescope is roughly equivalent whether the air support system for the primary is turned on or off. However, as is obvious from the curves in Fig. 2, the ultimate performance of the instrument does not seem to be significantly changed, independent of whether the air support system on the primary is

functioning or not. While this may be of some concern to the design people interested in the proper primary support, it is certainly an encouraging indication that the system is much less sensitive to primary support than might have been originally thought.

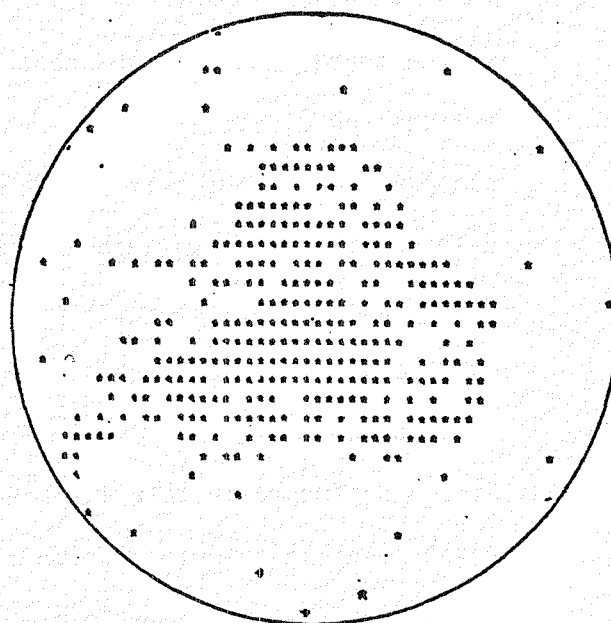
Fig. 3. Return Images from Point Source Test of
Static System Test (Air Support Off).

from this test are shown in Fig. 2. The images are roughly triangular in shape because the air was turned off under the primary support. Also the two images, the one from the centered secondary and the one from the secondary at the end of its chop cycle, although slightly different in structure, are approximately the same size and shape. This leads us to the conclusion that the chopping secondary does not significantly enlarge the diameter of the image because the telescope is used in the chopping mode. The tilt of the secondary is sufficiently small that it does not introduce a large enough amount of coma to significantly degrade the image size. Although in these two photographs it is difficult to see any scale, the scale of these photographs is the same as those seen in Fig. 4. By comparison we can conclude that the images in Fig. 3 are approximately 4 seconds in diameter. This is a satisfying result when we compare this photograph of the return image with the size calculated from the interferometric results in the static test.

RETURN IMAGE AT
ZERO CHOP OFFSET
(SECONDARY ON AXIS)

RETURN IMAGE AT
END OF CHOP CYCLE
(SECONDARY AXIS TILTED)

COMPUTER SIMULATION OF RETURN
IMAGE BASED ON STATIC SYSTEM
TEST WITH PNEUMATIC PRIMARY
SUPPORT NOT WORKING

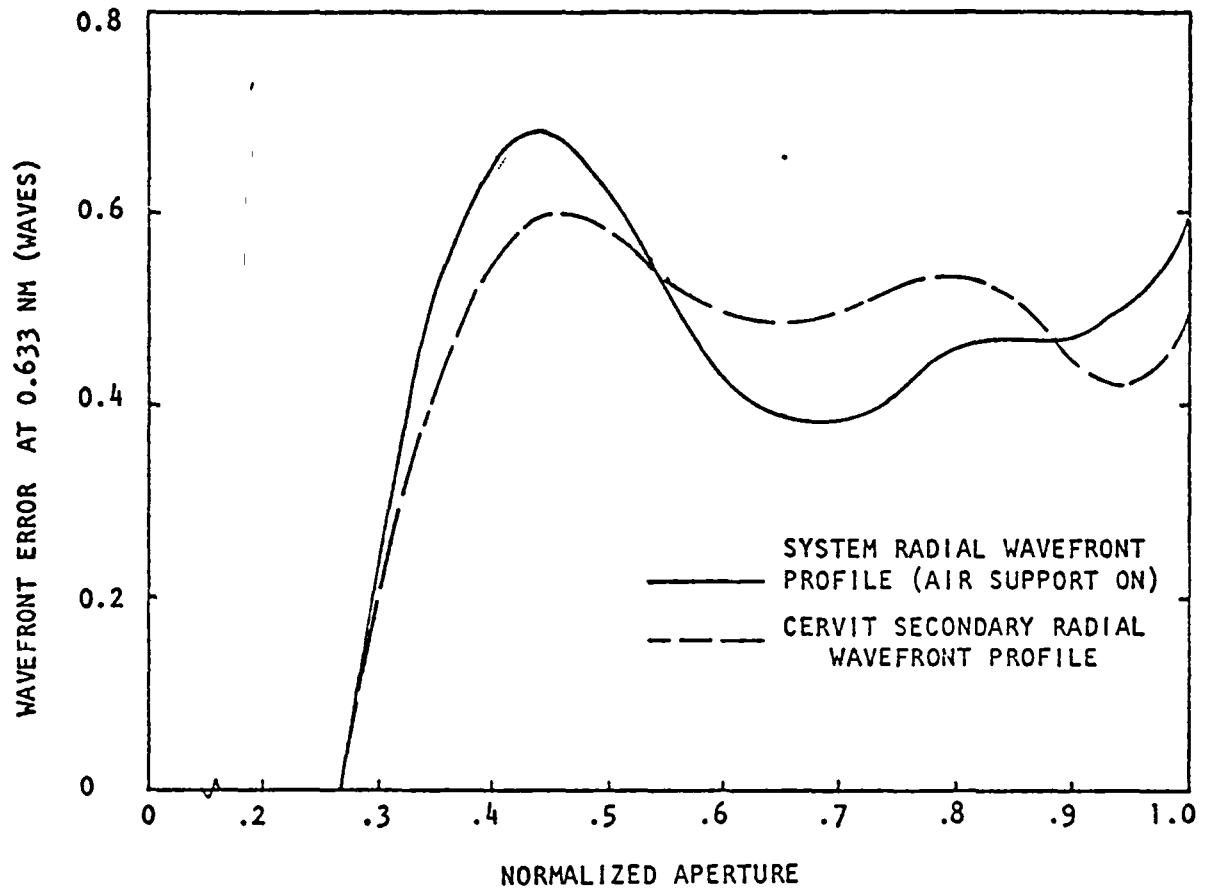
Fig. 7. Comparison of System and Cervit Secondary Average Radial Wavefront Profile.

profile, or the wavefront produced by this mirror with a radial profile of the wavefront of the total system. Figure 7 shows these two average radial profiles. As may be seen, both average radial profiles show a severe down edge at the inner edge and at the outside of the aperture both show an up edge. Over the central annulus of the aperture, the two profiles differ by less than a tenth of a wave. The great similarity between these two average radial profiles is a strong indication that the error in the system average radial profile is due almost entirely to the secondary mirror. This conclusion is further supported by the very high quality of the primary mirror as will be reported later. The Cervit secondary mirror had this zonal error as its only major figure defect. It was virtually free of astigmatism and other azimuthally varying errors. The peak-to-peak wavefront error produced by Cervit secondary mirror was 0.87 waves.

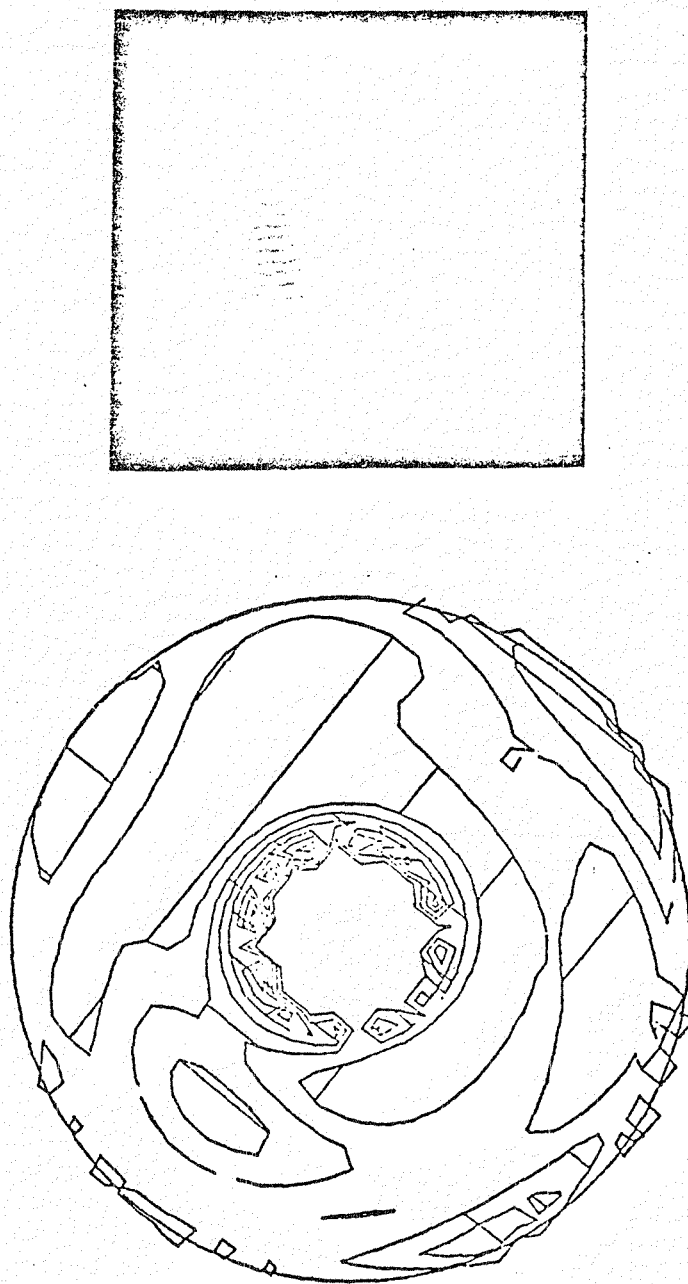
Fig. 8. Interferogram and Wavefront Contour Map of Cervit Secondary.

The fused silica secondary was tested in exactly the same fashion. This secondary mirror appeared free of zonal or radial irregularity. However, it did suffer from nearly 0.7 wave of astigmatism. This error was the principal optical defect of this component although it was coupled with other irregularities to give a peak single pass wavefront error of 1.4 waves. Thus, the Cervit secondary mirror, in spite of the error at its center, is the better mirror by almost a factor of two in wavefront. Figures 8 and 9 show the interferograms of these two secondary mirrors as well as computer-reduced contour plots of the wavefronts the two mirrors produce.

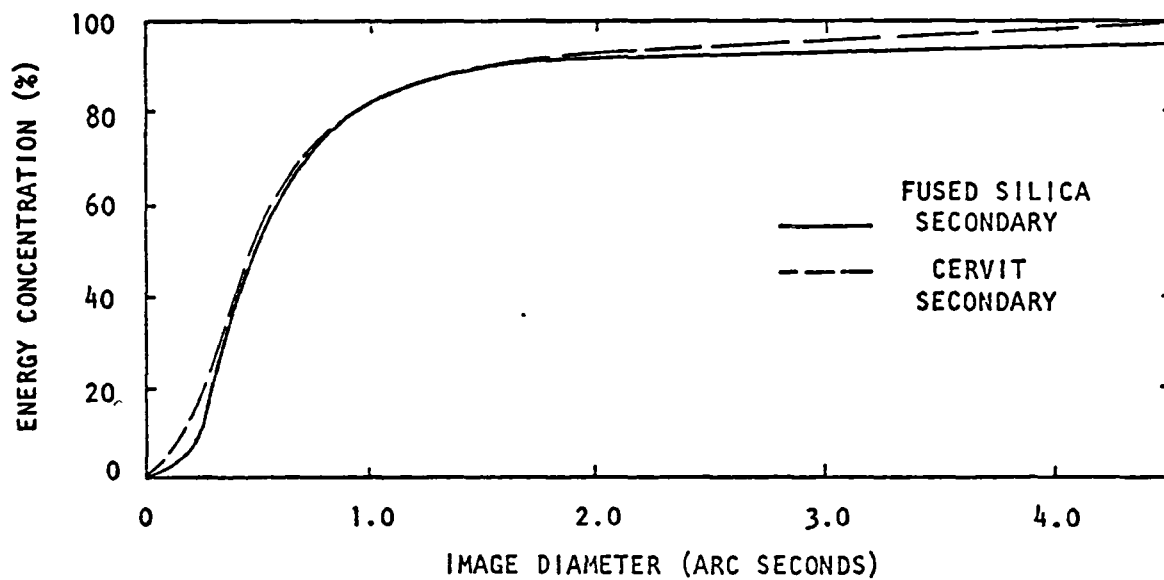
Fig. 10. Energy Concentration vs Image Diameter for the Fused Silica and Cervit Secondary Mirrors.

the center hole of the secondary mirrors. This was done to insure that the difference in error was not caused by the method of mounting the secondary mirrors and that the fairly large amount of astigmatism was not induced by any defect in mounting. Another reason for repeating the tests was that there had been some confusion as to which secondary mirror was the better of the two. The repetition of the test led to the same conclusion as before that the Cervit secondary mirror was somewhat better than the fused silica mirror.

The final matter regarding the secondaries concerns whether or not the Cervit secondary was manufactured to a tolerance of 2 arc seconds or better. Although it is somewhat difficult to find the radial energy distribution for a single component, we have used the fringe reduction program to calculate the effect of the wavefront errors shown in Figs. 8 and 9 on the radial energy distribution produced by these mirrors. Figure 10 shows the energy distribution produced by the secondaries on the system assuming that other components were perfect. This analysis shows that the Cervit secondary was made to better than the 2 arc second specification and the fused silica secondary is not as good but still better than 2 arc seconds.

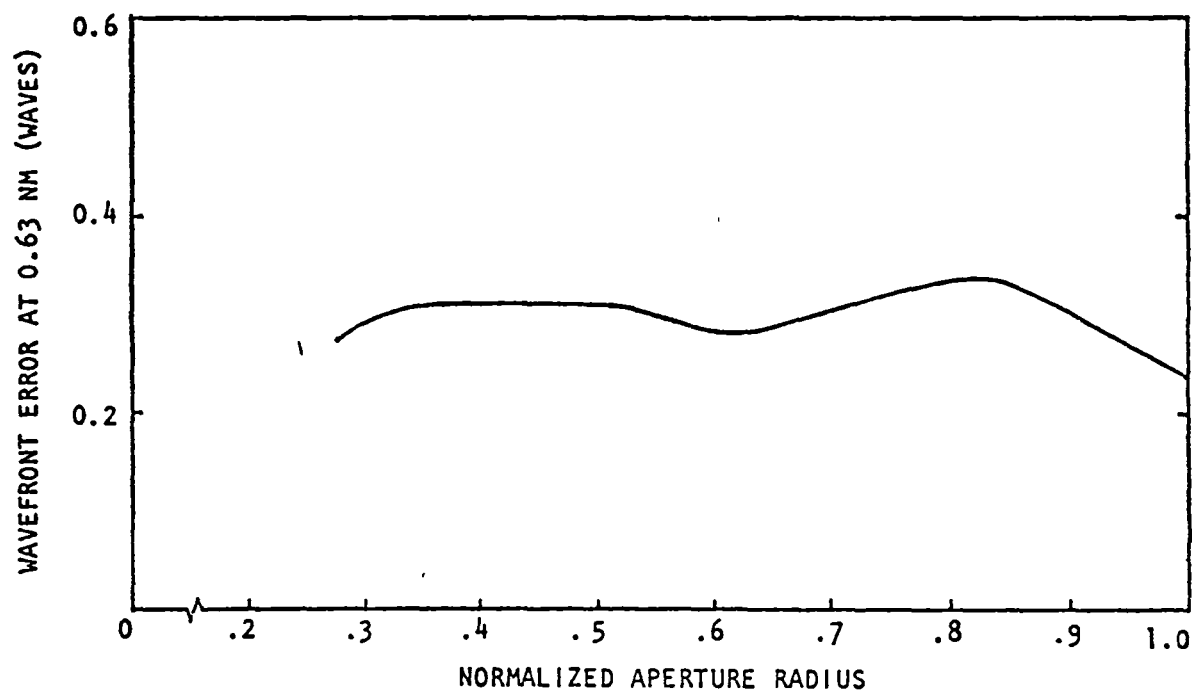
Fig. 12. Average Radial Wavefront Profile of Primary Mirror.

The data taken from the interferometer were divided by two because this is a double pass test and were analyzed by the FRINGE reduction program. Figure 12 shows the average radial profile of the primary mirror. As is immediately obvious, the departure from the correct curve affects the wavefront by less than a tenth wave. Thus the mirror surface has a radial profile of better than 1.20 wave. This represents an extremely small manufacturing error on a mirror of this speed. Figure 13 shows the contour map of the wavefront produced by this mirror. The wavefront has a peak-to-valley error of 0.46 wave. The surface of the mirror is better than a quarter wave, an extremely fine primary mirror. In Fig. 14 we show the radial energy distribution in the image assuming that all the other components in the telescope are perfect and that only the primary mirror is contributing to the spread in the radial energy distribution. As can be seen from the figure, the primary mirror is superior in performance to the secondary mirrors. Both the radial energy distribution of the primary in Fig. 14 and that for the secondary

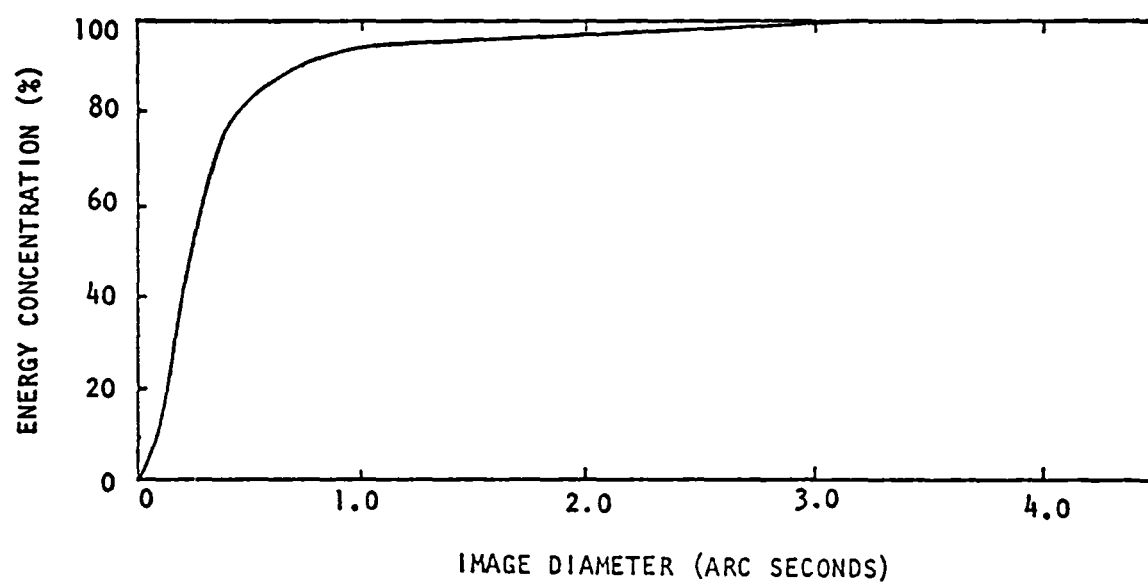
Fig. 14. Energy Concentration vs Image Diameter for the Primary Mirror.

mirrors in Fig. 10 are plotted to the same scale. Clearly, the primary mirror is close to perfect, and if one wished to make the system better, an obvious place to begin would be with work on the Cervit secondary mirror.

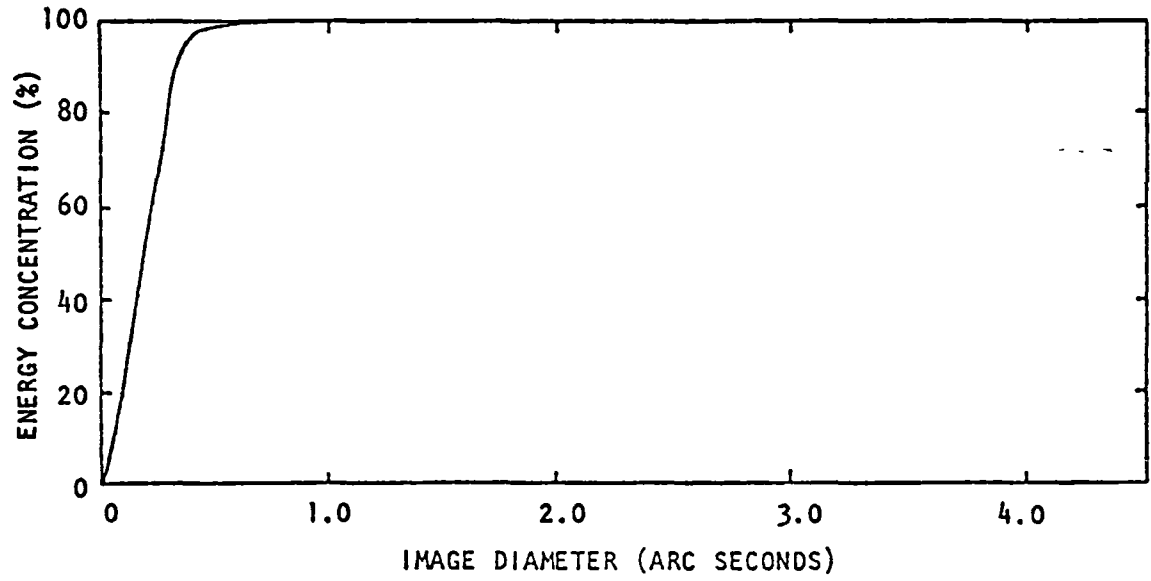
Fig. 16. Energy Concentration vs Image Diameter for the Tertiary Mirror.

The final component of the system that was tested was the tertiary mirror. This plano mirror was tested in the classical fashion using the Ritchey-Common Test shown in Fig. 15. The advantage of using this test is that the mirror is tested at a 45° angle of incidence just as it is used in the telescope. Thus the wavefront produced by the mirror gives a one-to-one correlation with its effect on the telescope. The result of this test showed that the tertiary mirror had almost exactly one half wave of pure astigmatism. This amount of astigmatism in the tertiary mirror would be itself contribute a 0.33 arc second blur to the image. Figure 16 shows the radial energy distribution calculated for the tertiary mirror assuming the primary and secondary of the system are perfect.

We were surprised that the tertiary mirror had this large a figure error. It should be pointed out that these tests were run after the tertiary mirror had been coated. We ran a very cursory check on the tertiary mirror over a portion of the aperture prior to coating and the mirror looked at that time to be flat, certainly less than a quarter wave. Thus we were surprised to find after coating that the mirror did appear to have about a half wave of astigmatism. This led us to believe, as will be pointed out below, that there may be a certain problem

with the exact method of mounting the tertiary mirror. Because of its placement in the telescope system, a rather small figure error in this mirror will have an effect on the angular diameter of the final image of the telescope. Thus it is imperative that this mirror be properly mounted.

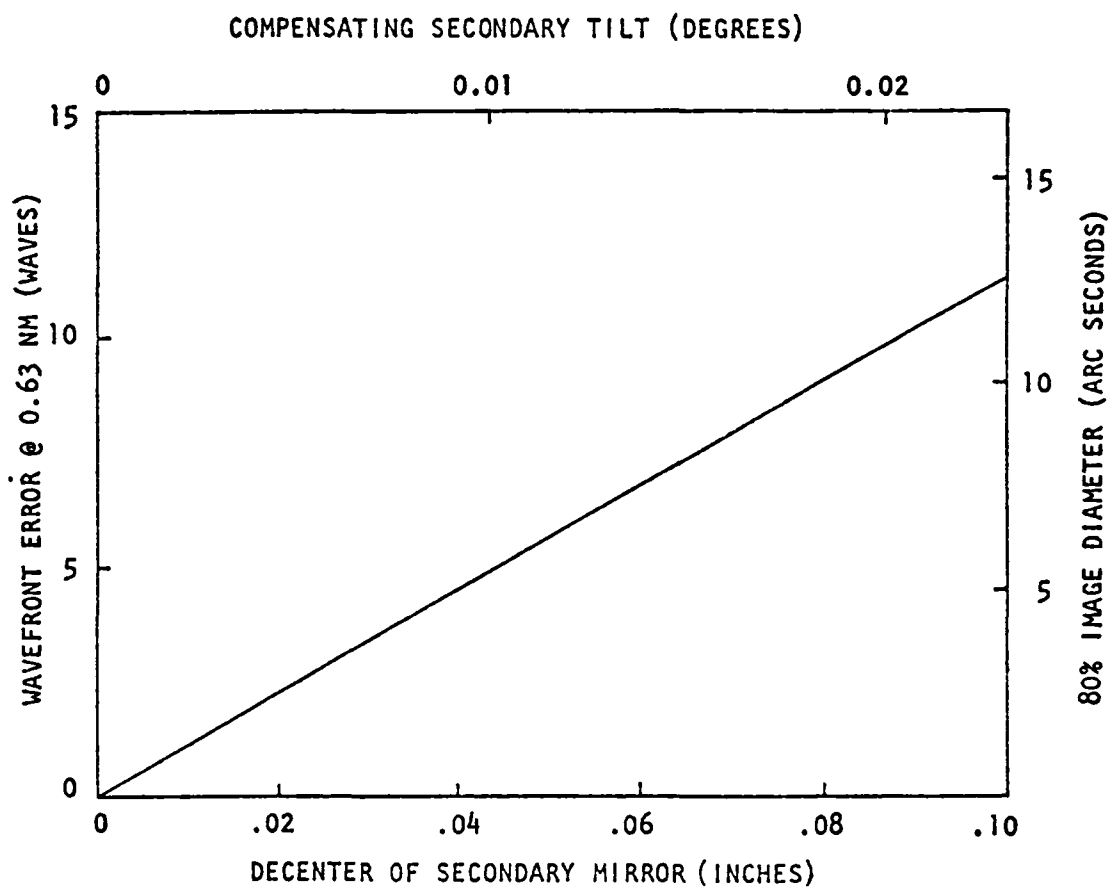
Fig. 17. Coma Introduced by Decenter of Secondary Mirror.

A second area of mechanical problems arose with the secondary mirror. There was approximately 0.75 mm clearance between the hole in the secondary mirror and the stud on which it was mounted. Thus every time the secondary mirror was removed and replaced on the study, the centration of the mirror could have changed as much as 0.75 mm. Figure 17 shows the impact on image quality of this type of decentration of the secondary mirror.

Clearly, this large a decentration made it difficult to obtain proper alignment of the telescope. Therefore, we had a new Invar mounting stud manufactured in our shop with a clearance of 0.05 mm. With this new stud, the secondary mirror can be removed and replaced with minimal effect on the alignment of the telescope.

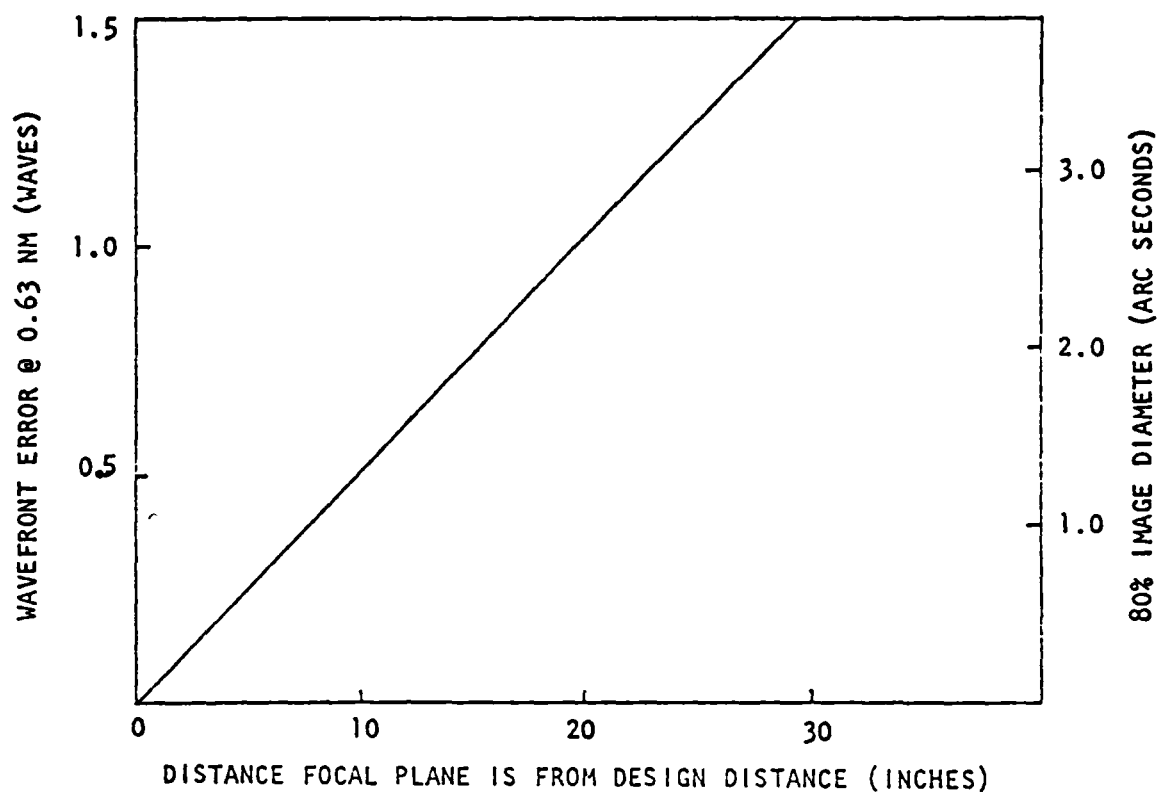
Fig. 18. Spherical Aberration Introduced by Using Telescope at Focal Plane Other Than That It Was Designed for.

The second area concerns mis-spacing between the primary and secondary mirrors. With the Cervit secondary mirror, the nominal design distance between the secondary mirror and the focal plane is ~ 3 m (124 in.). This gives the instrument a magnification of 8 with an f/17 output beam. It turns out that some experimenters' packages do not mate with the telescope so as to use the focal plane at this position. In Fig. 18 we show the effect on image size as the focal plane is shifted from its designed location of ~ 3 m (124 in.). If the image plane should be shifted 36 cm (14 in.) farther back or away from the telescope, it will introduce roughly 0.75 of a wave of spherical aberration that will produce and 80% spot diameter of 1.8 arc seconds. Again, it is obvious from the curve in Fig. 18 that this is a linear effect and the farther one gets from the nominal focal plane of the instrument the worse matters become. For experimenters working into the IR region this is probably no detriment, but to persons working in or near the visible, in the absence of other image defects, this can be a problem.
